# Manhole Inspection Summary

Manhole # S11EE2006MH

Insp Date: 11/1/06 12:37 PM

**Location** Address: **2215 CROSS COUNTRY BLVD**

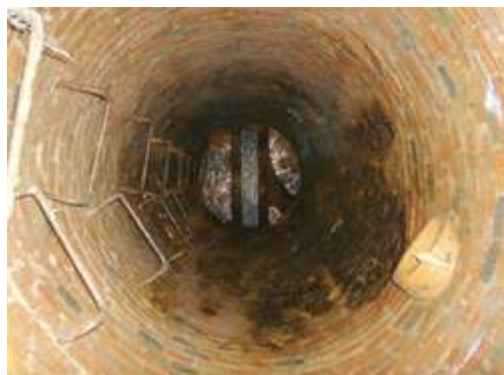
Top View

Adjustment, Corbel, and Barrel infiltration.  
Bench debris.

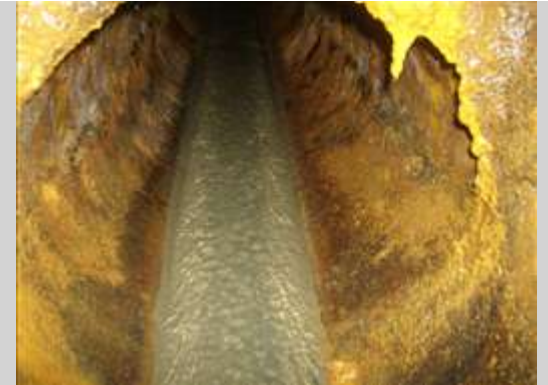
### 21 in. Circular Gravity Sewer Pipe Out @ 12 O'Clock

Invert Depth: **25.03** (ft.) Flow Characteristics: **Slow**

Infiltration: **None** Pipe Seal Cond: **Unknown**

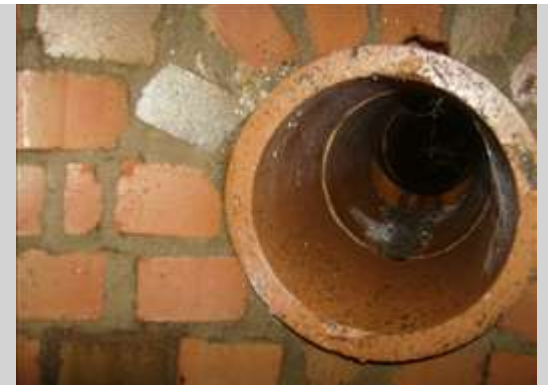
### 8 in. Circular Gravity Sewer Pipe In @ 3 O'Clock

Invert Depth: **5.13** (ft.) Flow Characteristics: **Slow**

Infiltration: **None** Pipe Seal Cond: **Unknown**

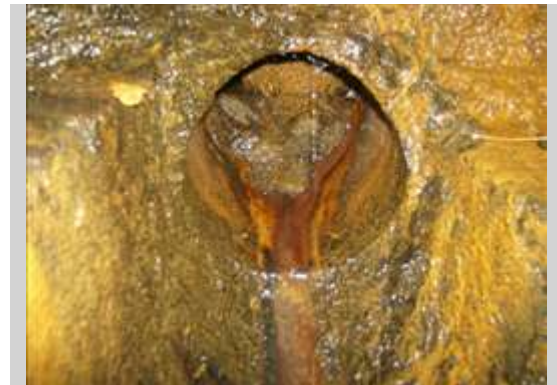
### Drop In @ 4 O'Clock

Drop: **Outside** Rod and Bar

Drop Condition: **Partly Clogged**

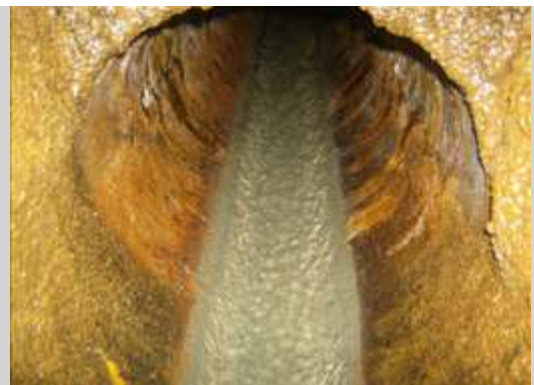
21 in. Circular Gravity Sewer

Invert Depth: **24.94** (ft.) Flow Characteristics: **Slow**

Infiltration: **None**
